Fonte: Ground Engineering, September 2005

SLOPE ENGINEERING

BACK FROM THE BRINK

A huge stabilised slope is being built in northern Italy to prevent an "inland tsunami". Damon Schünmann investigates.

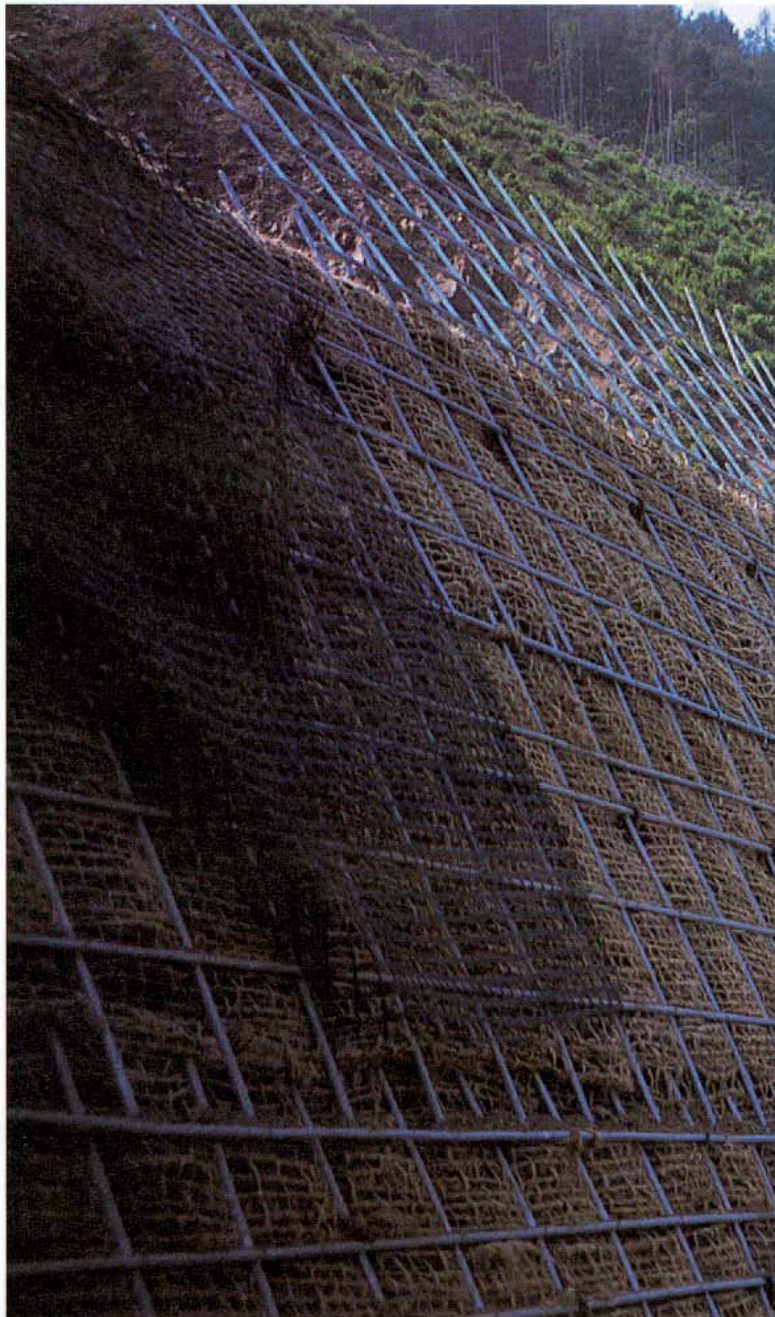
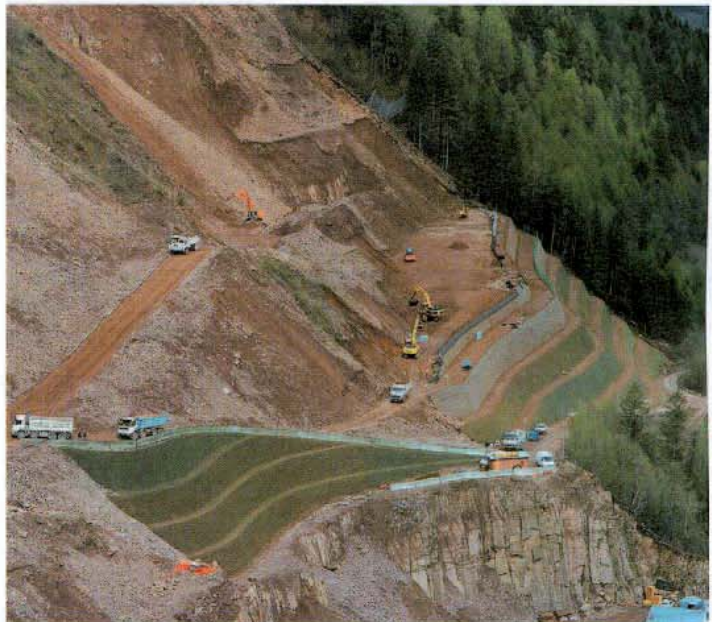
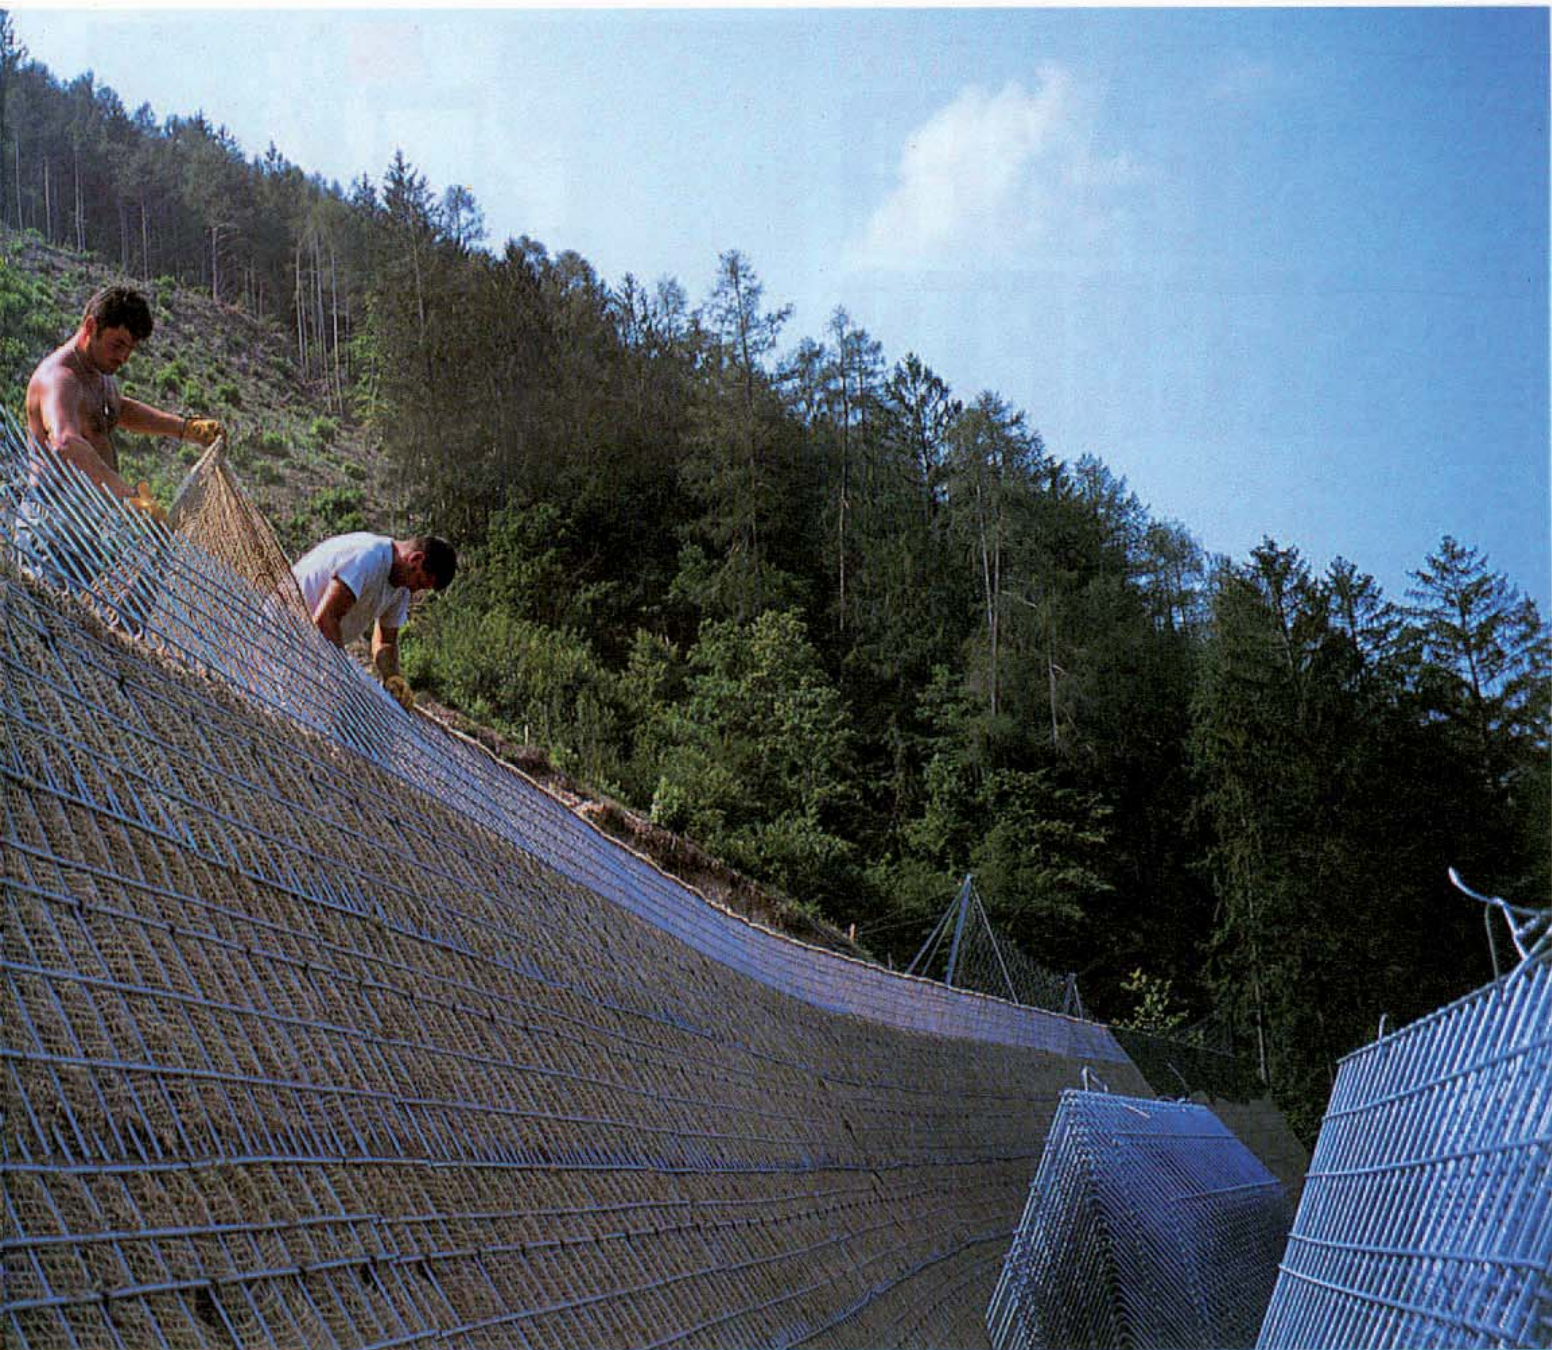
The 60m high slope at Lases has been benched and reinforced with geotextile to prevent a potentially catastrophic failure.

And, crucially, the foot is being stabilised with 300,000m³ of crushed porfido fill stabilised in a benched profile reinforced with geotextile.

Although the reinforcement structure is fairly typical, what makes it stand out is its sheer size: 60m high. Fantini says he has not heard of a taller one in Europe. The impressive height is reached in 12.5m benches, "a sophisticated design in terms of stability, prediction of movement and deformation", he says.

The primary reinforcement material for the slope is Huesker's 110kN Fortrac 110/30-20 with 45kN For-

The 60° sloping face of each bench is hydro-seeded with a mixture of seeds, water, fertiliser and glue. This will allow erosion-resisting vegetation to take hold among the Geojute degradable matting Lago is laying over the front of the slope, which will also retain smaller fragments of porfido within the benches.
